COMMITTEE OF ADJUSTMENT June 24th, 2020 COMMITTEE AGENDA

- **DATE:** June 24th, 2020
- **REPORT NO:** PD-059-20
- SUBJECT:Recommendation ReportPamela, Gary & Gale Davis (Agent Upper Canada Consultants)Application for Minor Boundary AdjustmentFile No. B02/2020WL
- **CONTACT:** Brian Treble, Director of Planning and Building Gerrit Boerema, Planner II

Environmental Impact Study Niagara Pallet

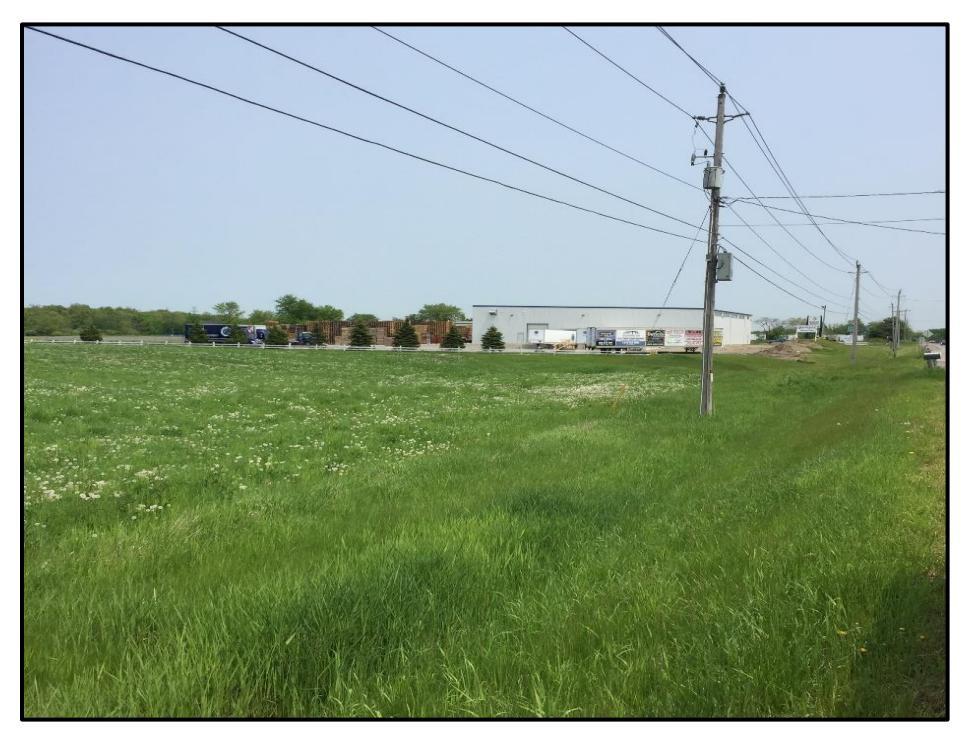
Photograph 1. Niagara Pallet and Proposed Expansion Area Along the North ROW of Highway 20 Looking East

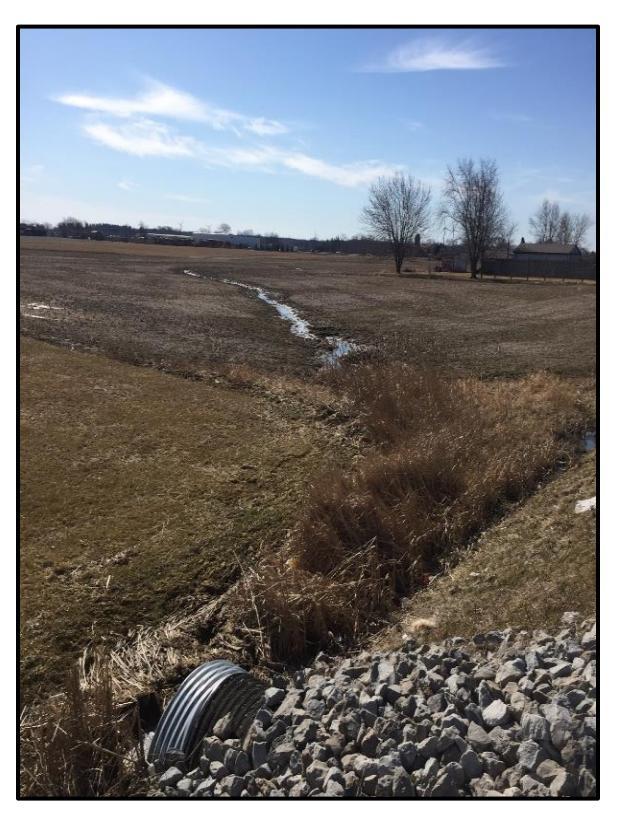
Photograph 2. Watercourse Upstream of Subject Lands at the Grimsby Road (County Road 12) Culvert Looking Downstream to the Subject Lands (March 2019)

Aquatic resources within the subject lands consist of a mix of agricultural swales, roadside ditches and commercial storm drain swales with a northwest-southeast drainage gradient. The watercourse that flows through the proposed expansion area has its origins 1.2 km upstream of the subject lands and is conveyed to the site via a culvert under Grimsby Road (County Road 12) 575 m upstream of the subject lands (**Photograph 2**). South of Grimsby Road the shallow watercourse flow through active agricultural fields onto the subject lands (**Photograph 3**).

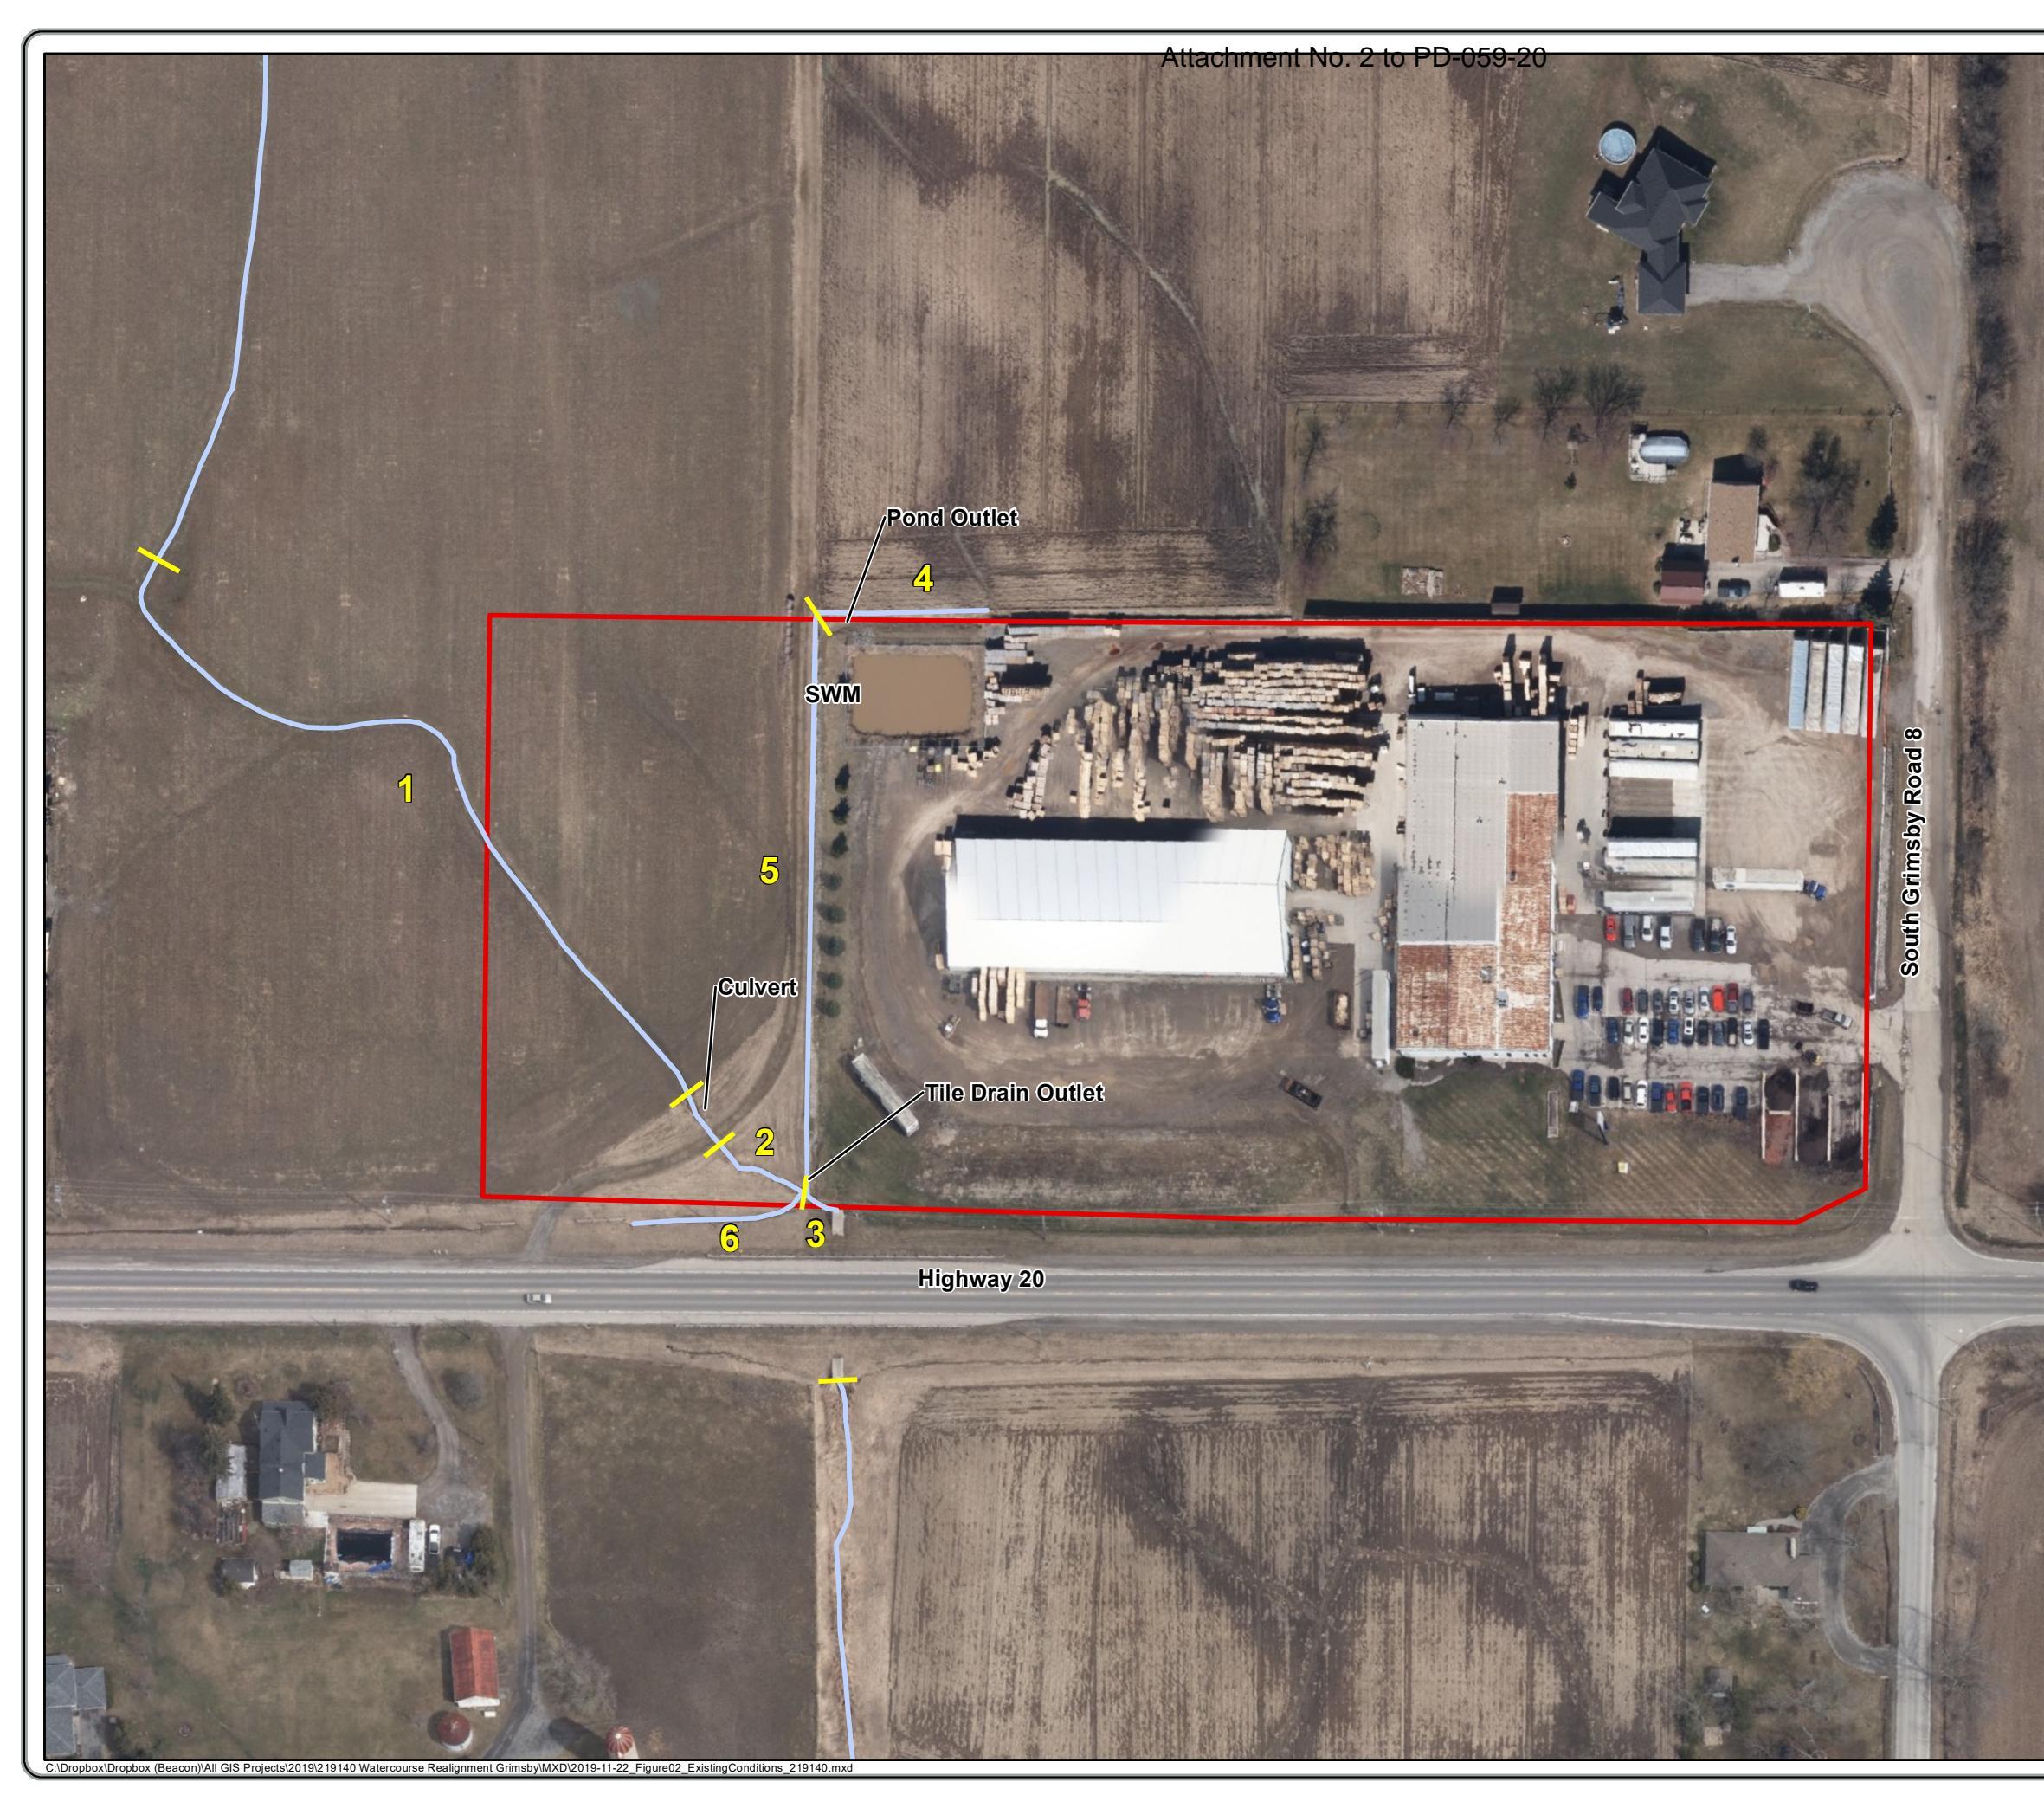
25
P-1	Existing Conditions	Figure 2
	Lot Addition and Site Plan Appr West Lincoln Regional Municipality of Niaga	oval, ara
	Legend	
	Subject Property	
	Reach Break	
	Watercourse (MNRF 2019)	
The second		
AND DO		
Ser Sale		
	BEACON Project: 21	9140 Jary 2020
	Client: Niagara Pallet Prepared by: DU Checked by: RH	J
		50 m
	Contains information licensed under the Open Govern Ontario Orthoimagery Baselayer: FBS Niaga	nment License– ra 2018

The following provides a description and assessment of the natural heritage features and functions that are found within the boundaries of the subject lands. This assessment is based on detailed field surveys that were undertaken by Beacon ecologists through the spring and summer of 2019. **Figure 2** presents the features that are detailed in the following sections of the report.

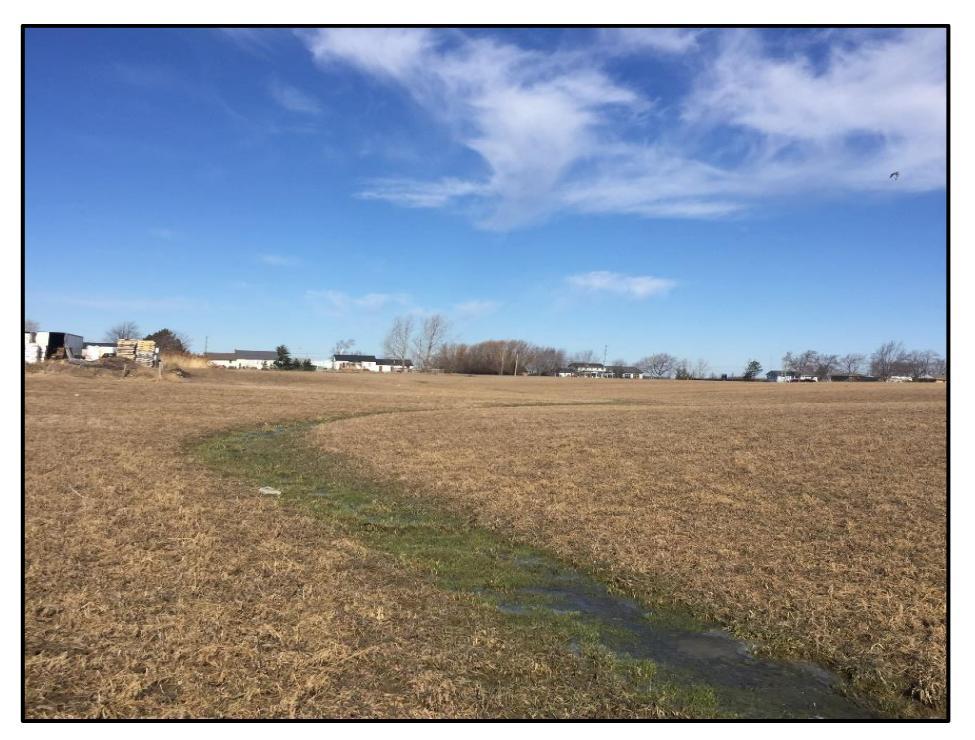
Photograph3. Watercourse Upstream of Subject Lands at the Boundary of the Proposed Expansion Area Looking Upstream from the Subject Lands (March 2019)

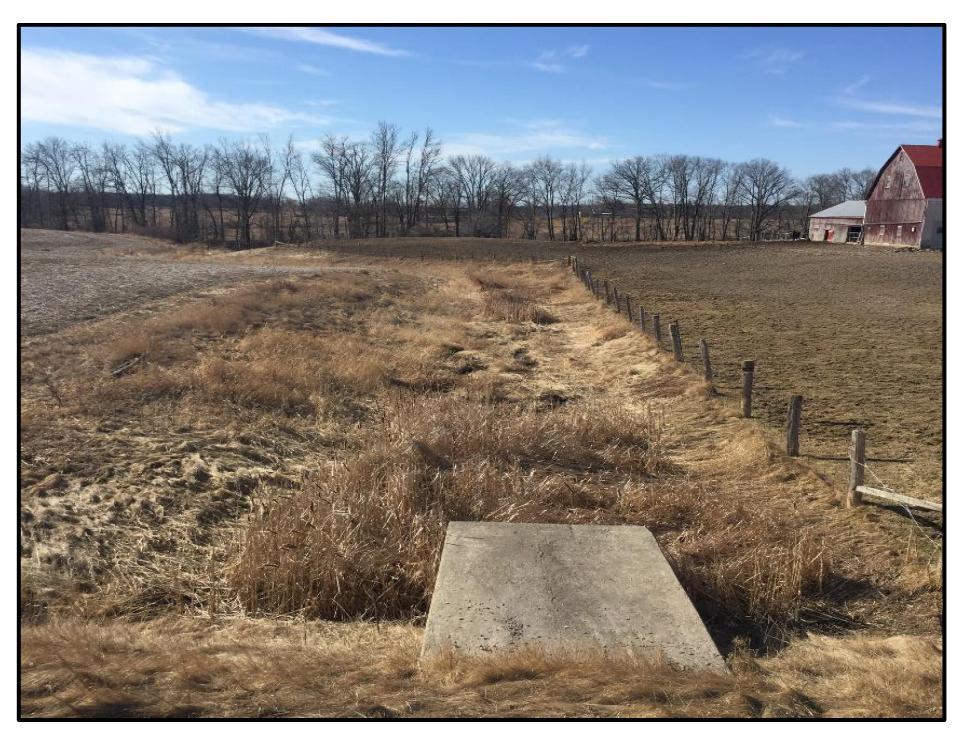
Photograph 4. Watercourse Culvert Crossing at Highway 20 Looking Downstream Form Highway to Twenty Mile Creek (March 2019)

The watercourse exits the subject lands via a concrete box culvert under Highway 20 (**Photograph 4**) and discharges to Twenty Mile Creek 160 m downstream of the highway (**Photograph 5**). Surveys of this watercourse from March through August did not observe fish and given the shallow and ephemeral flows it is assessed to not provided seasonal or permanent fish habitat.

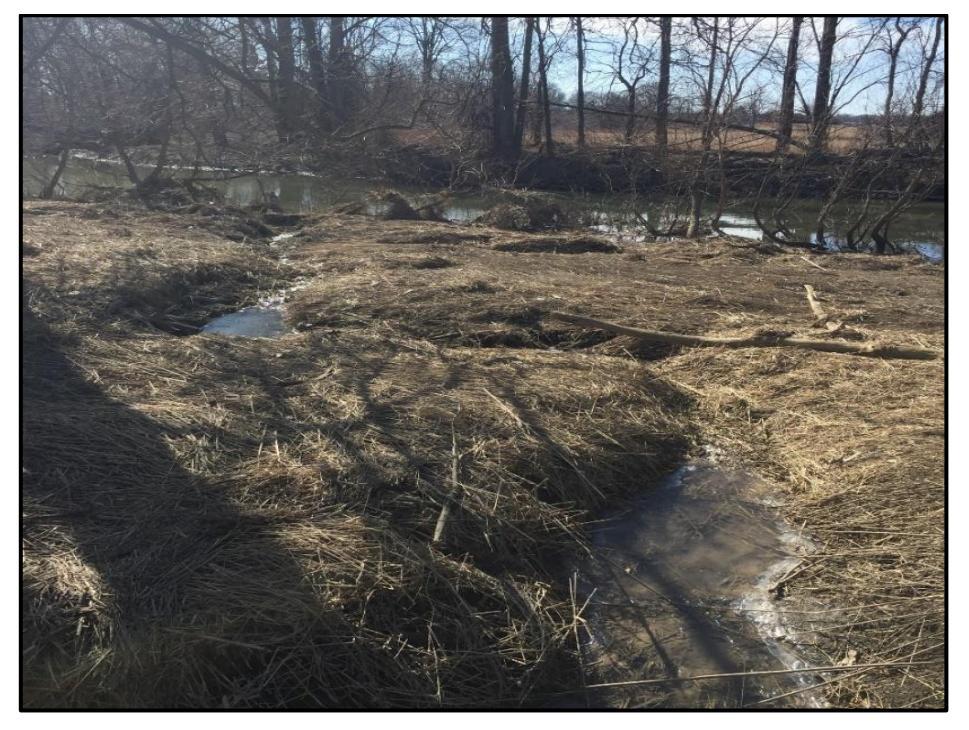
Photograph 5. Watercourse Confluence with Twenty Mile Creek Downstream of Subject Lands (March 2019)

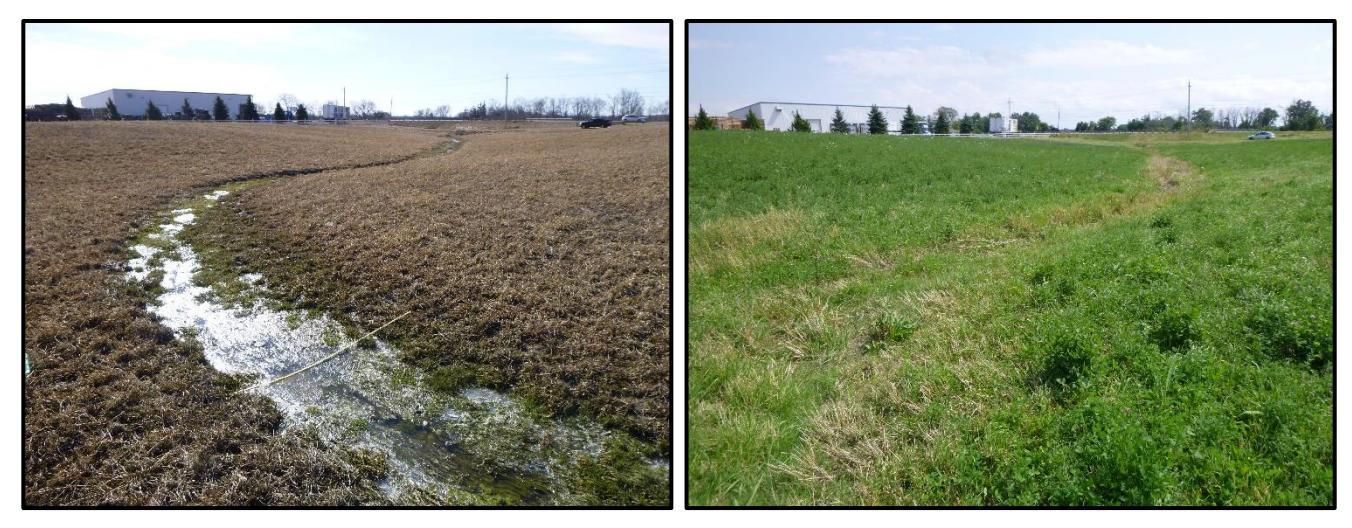
Photograph 7. Reach TM-1 March 27, 2019

Photograph 8. Reach TM-1 August 8, 2019

Reach TM-1 is located at the western-most portion of the property and gathers water from agricultural fields northwest of the subject property lands. This reach originates offsite of the subject property 1.2 km upstream. Reach TM-1 ends just upstream of the agricultural culvert crossing located immediately to the west of the subject property. This reach exists exclusively within cropped lands (**Photographs 7 & 8**). The watercourse has a maximum bank full width that varies between 1.5 to 2.5 m and during the peak flows in March has a wetted width between 0.5 and 1 m and wetted depth that varies between 2 to 5 cm.

This reach provides valued hydrologic function as flowing water was present during the March and June site visits with minimal standing water observed in August. This reach was affected by agricultural modifiers, however, during the 2019 monitoring year the adjacent cropped area was used for nurse crops such as clover and alfalfa with no observations of tilling or disking. No perennial or seasonal fish habitat is offered by the reach but allochthonous material and nutrients is supplied to downstream aquatic habitats.

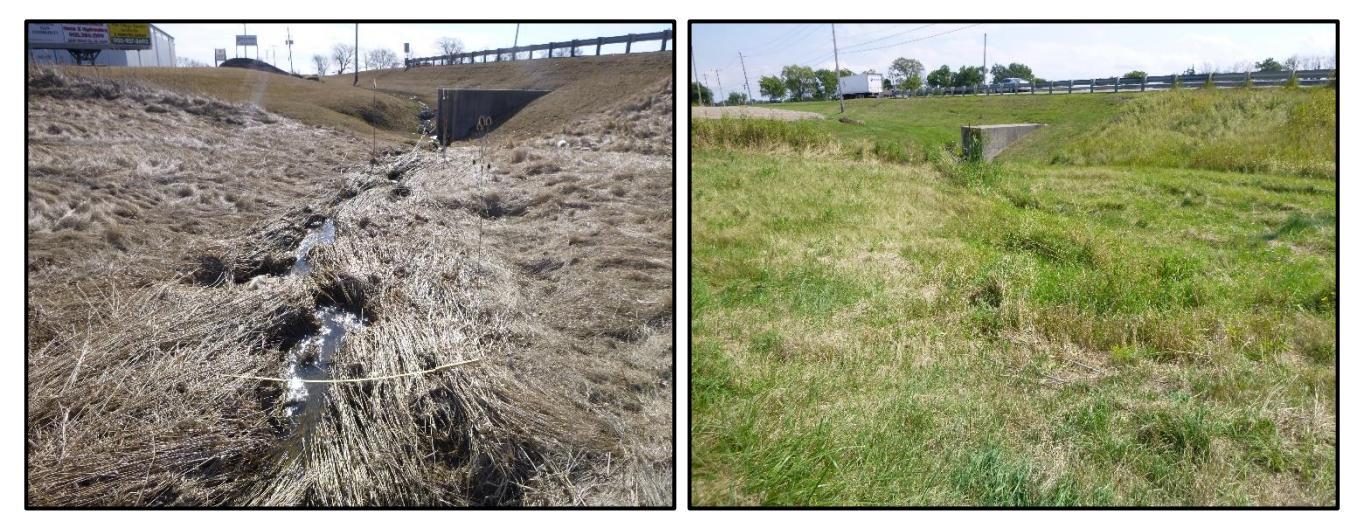
Photograph 9. Reach TM-2 March 27, 2019

Photograph 10. Reach TM-2 March 27, 2019

were similar to TM-1 for this reach (**Photographs 9 & 10**). The riparian area for this reach was identified as cultural meadow vegetation community. This reach likely supplies nutrients and material to downstream reaches.

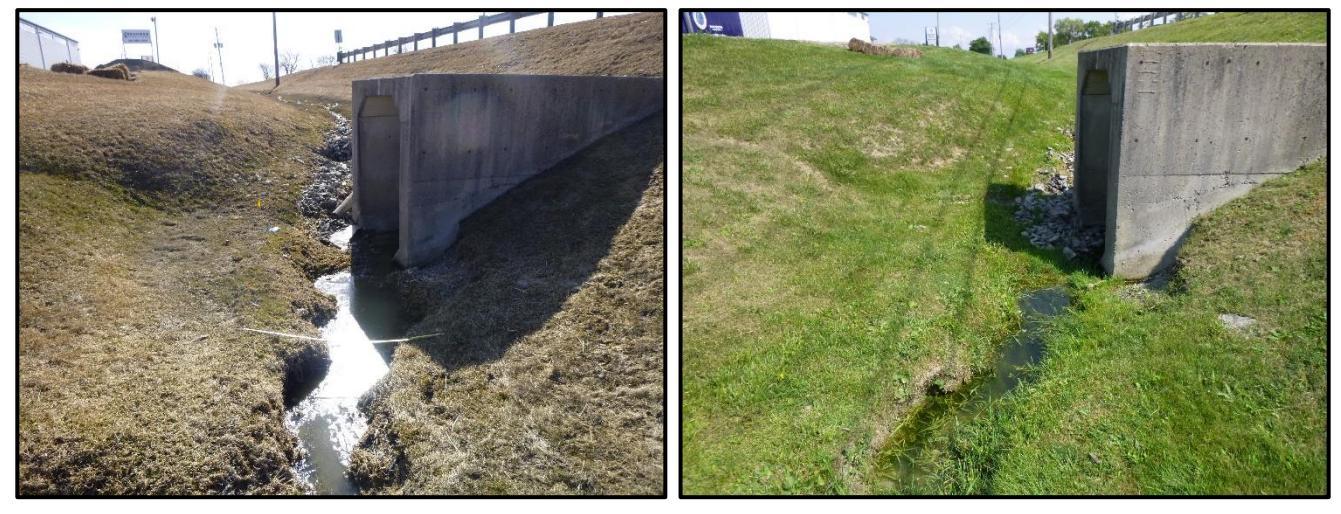
Photograph 11. Reach TM-3 March 27, 2019

Photograph 12. Reach TM-3 August 8, 2019

Reach TM-3 is approximately 5 m in length originating from the confluence of reaches TM-2 and TM-5. Flowing water was observed within this reach in March and June and standing water observed along its length during the August site visit (**Photographs 11 & 12**). The channel has wetted bank width of 0.75 to 0.9 m and March wetted depth of 28 to 45 cm. This reach may be affected from nutrient inputs as a result of upstream agriculture and industrial inputs. TM-3 exhibits manicured lawn riparian vegetation. A pool with standing water at the culvert had the potential to provide refuge for small fish, but no fish where observed throughout the monitoring season.

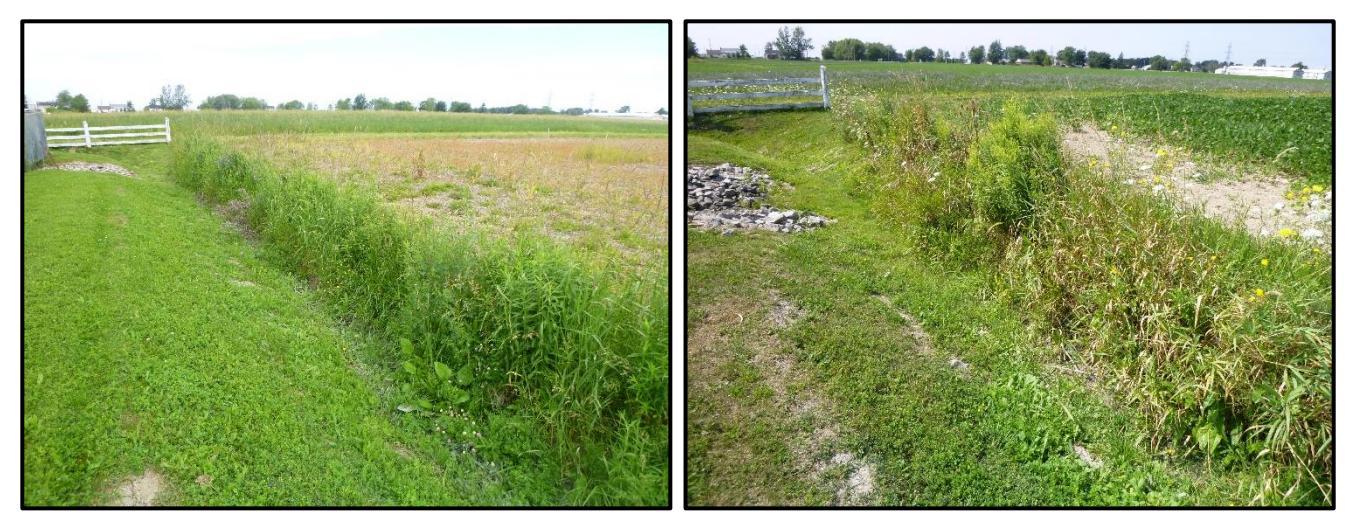
Photograph 13. Reach TM-4 June 27, 2019

Photograph14. Reach TM-4 August 8, 2019

Reach TM-4 is a 1.0-meter-wide dug ditch that runs between the north boundary of an onsite Stormwater Management (SWM) facility located at the northwest corner of the subject property and active agricultural fields to the north (**Photographs 13 & 14**). This reach was dry during all site visits; however, evidence of sheet flow drainage was observed from agricultural fields located to the north draining to this reach indicating potential flow collection during significant storm events or at the onset of spring freshet. No direct or contributing fish or terrestrial habitat is provided by this reach.

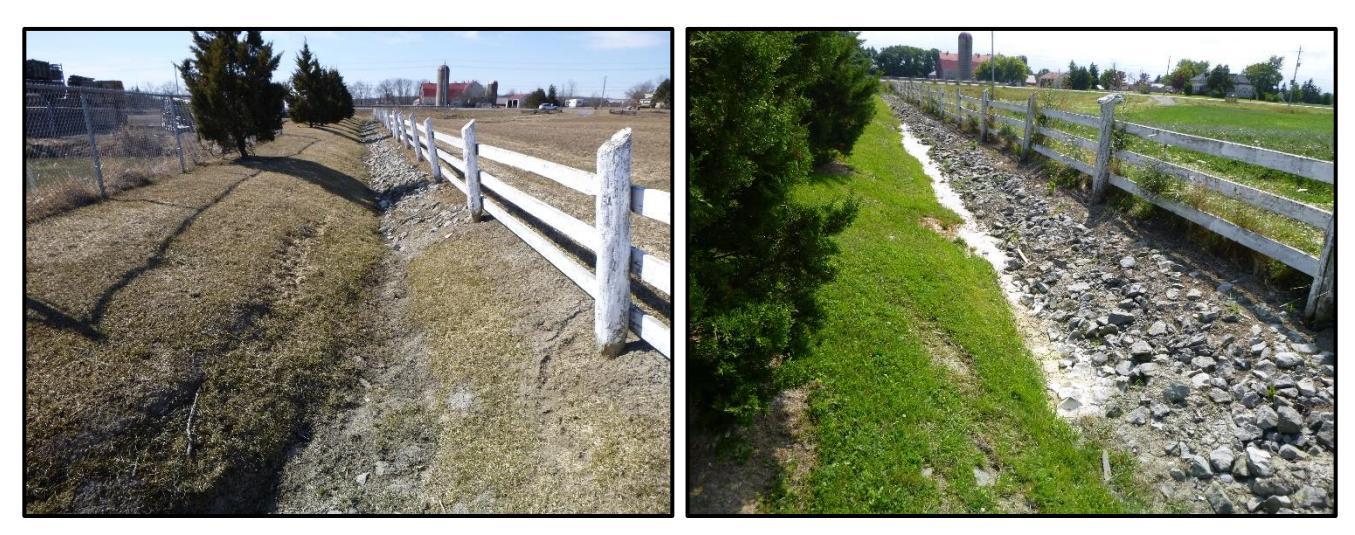
Photograph 15. Reach TM-5 March 27, 2019

Photograph 1. Reach TM-5 August 8, 2019

Reach TM-5 is a 1.3 m wide dug ditch that extends from the confluence between reach TM-4 and the SWM facility outlet located at the northwest corner of the subject property (**Photographs 15 & 16**). In addition to gathering flows from the SWM facility TM-5 also gathers drainage from the commercial parking lot. Standing water was present within this reach throughout the monitoring season. Contributions from this reach to fish and terrestrial habitat is minimal.

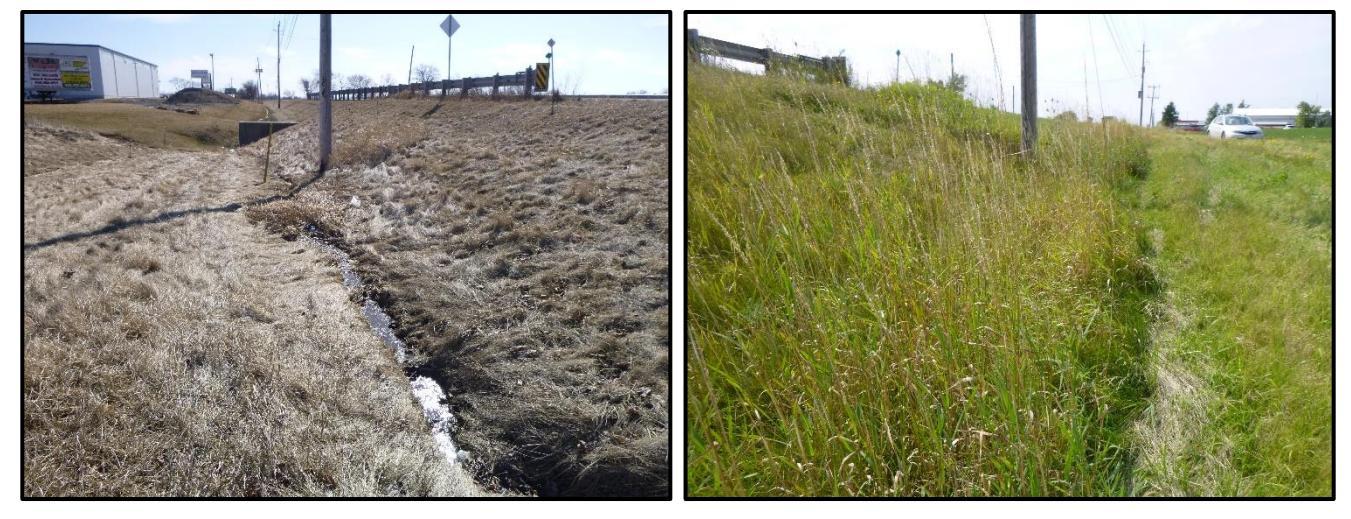
Photograph 2 Reach TM-6 March 27, 2019

Photograph 3. Reach TM-6 August 8, 2019

Reach TM-6 consists of a short portion of the Highway 20 roadside ditch line which confluences with TM-2 and TM-5 (**Photographs 17 & 18**). TM-6 is approximately 45 m in length and exists within a cultural meadow riparian area. Minimal contributions are provided to downstream fish and terrestrial habitat.

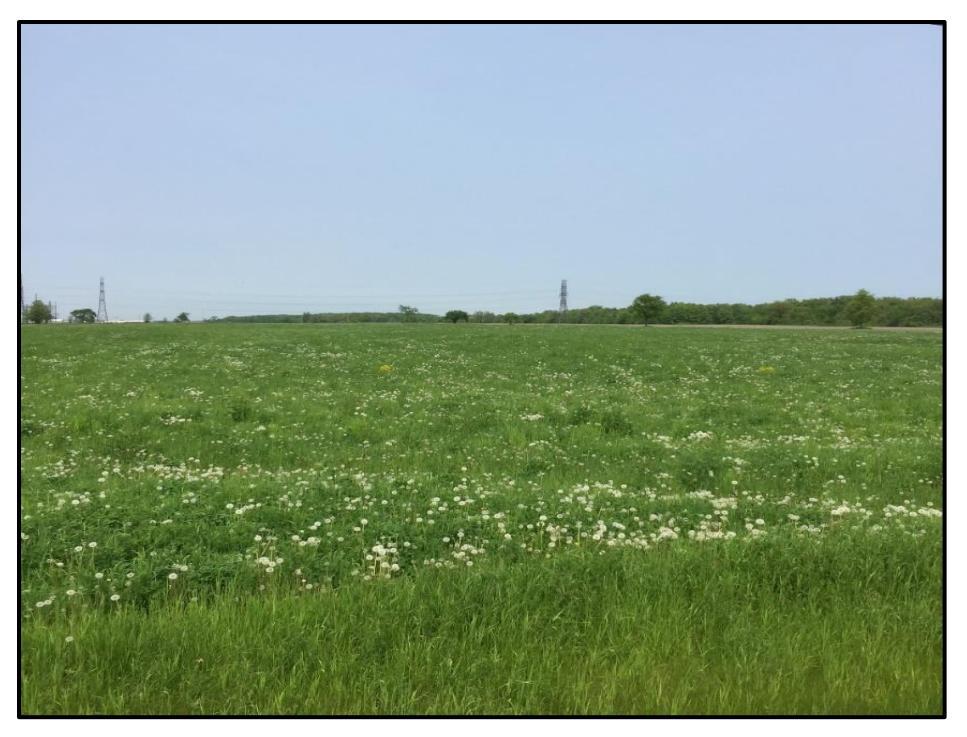
Photograph 19. Pasture/Hay Field Within and Surrounding the Subject Lands Looking North from Highway 20 (June 2019)

The proposed expansion area in 2019 supported agricultural pasture/hay field comprised of grasses and weeds (**Photographs 19, 20, 21**). Following the ELC it has been assessed to represent cultural meadow; however, the field is in a rotation and in the past has been ploughed and planted with corn and soya and will be again in the future.

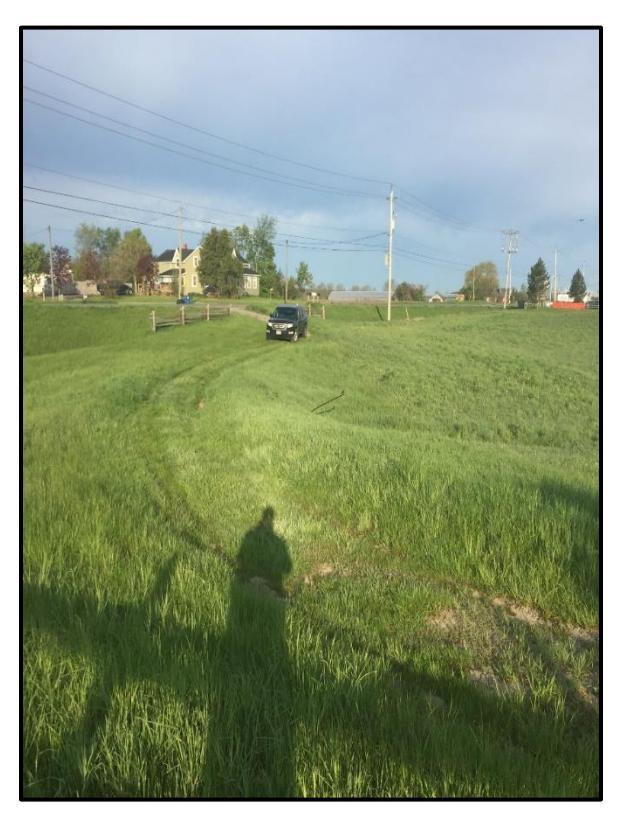
Photograph 20. Pasture/Hay Field Within the Proposed Expansion Area Looking West Along Highway 20 (June 2019)

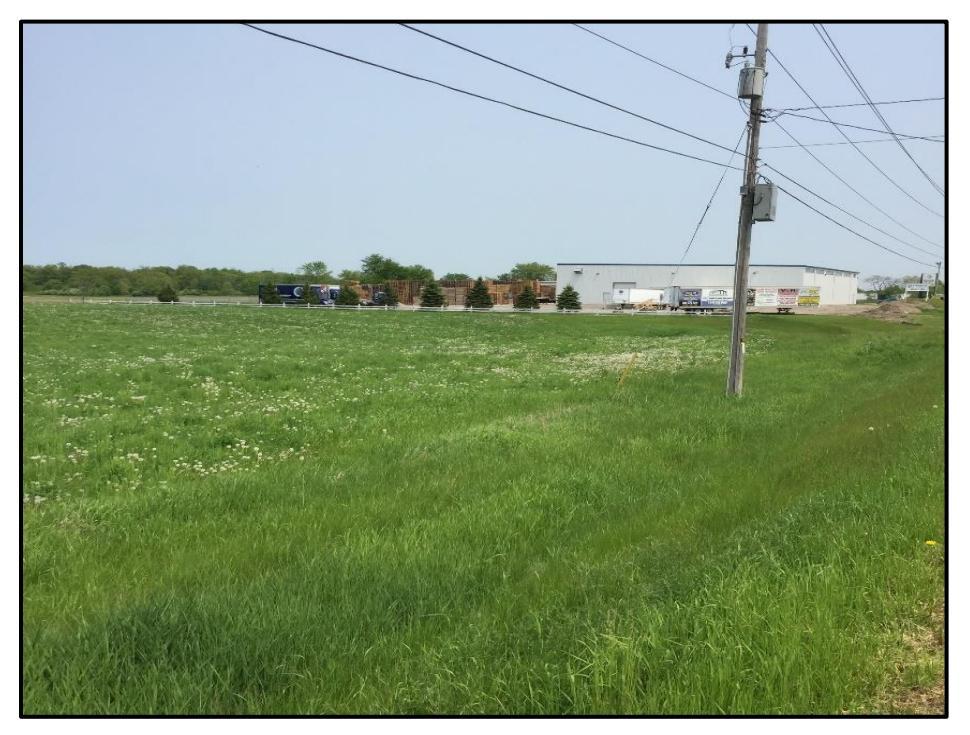
Photograph 21. Pasture/Hay Field Within the Proposed Expansion Area Looking East Along Highway 20 (June 2019)

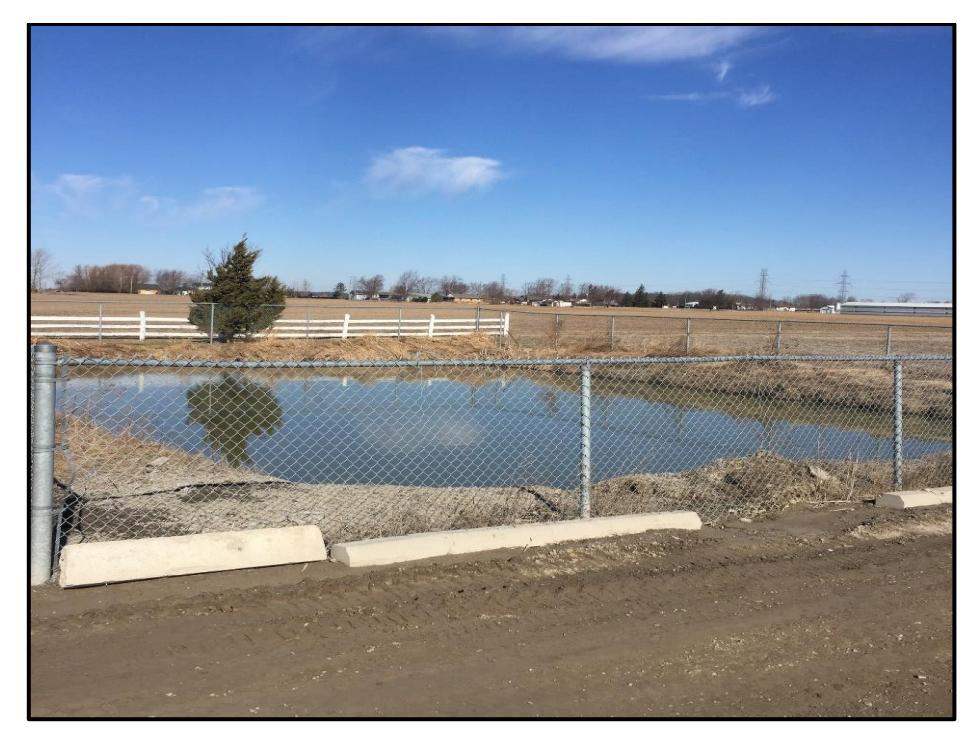
Photograph 22. Small Stormwater Pond of the Niagara Pallet Facility that is used as Amphibian Breeding Pond

No naturally occurring amphibian breeding habitat is found to occur within or adjacent to the subject lands. A small stormwater pond is associated with the existing Niagara Pallet facility (**Photograph 22**) and a number of Northern Leopard Frog (*Rana pipiens*) were observed along the banks of the pond and are considered to use the pond as a breeding site. No other species were noted.
